# Manhole Inspection Summary

Manhole # S51C\_\_031MH

**Location** Address: **1 N.Decker Ave.** Cross Street: **E. Fairmount Av**

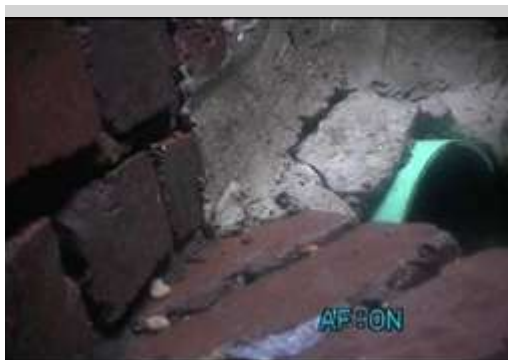
Miscellaneous

cracked seal at 3 o clock

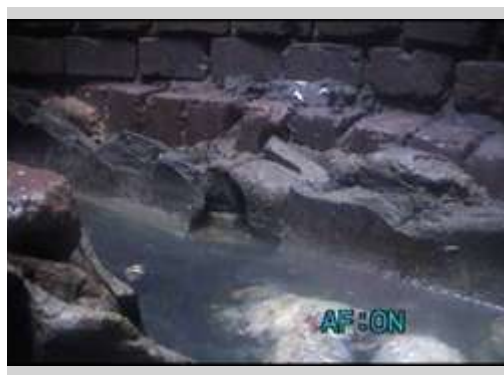
Defect 1

**Bench** ☒ Exists Material: **Brick** ☐ Parged  
Condition: ☐ Sound ☐ Cracked ☐ Root Intrusion ☒ **Deteriorated** ☐ Leaks ☐ Debris

**Channel** Material: **Brick** ☐ Parged  
Channel Exposure: **Fully Open** Junc Dist: **0** nearest .5 ft. Azimuth: **0**  
Condition: ☐ Sound ☐ Cracked ☐ Root Intrusion ☒ **Deteriorated** ☐ Leaks ☒ **Debris**

deteriorated bench & channel

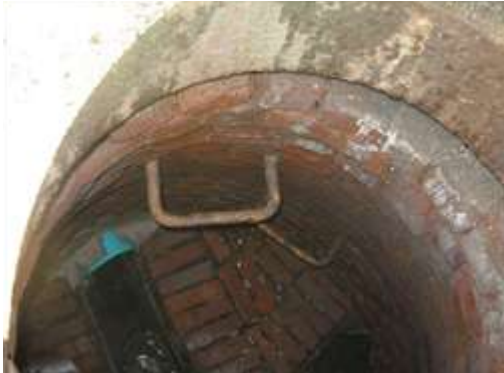
Defect 7

**Steps** Count: **2** Missing: **0** ☒ **Corroded**

corroded rungs

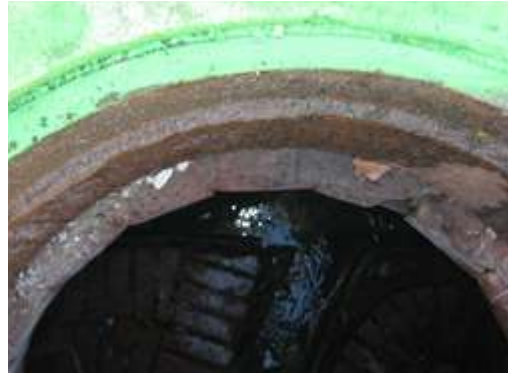
Defect 5

**Frame** Offset: **2.5** (in.) Condition: ☒ Sound ☐ Cracked ☐ Leaks

frame offset

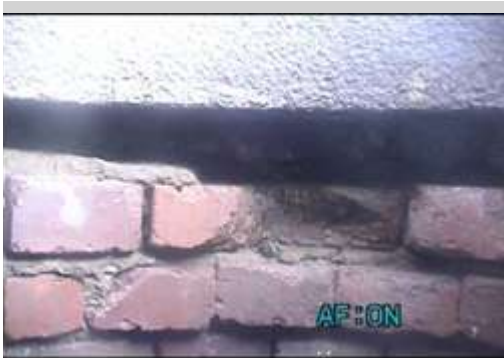
Defect 4

**Chimney / Frame Adjustment** ☒ Exists Material: **Brick** ☐ Parged Height: **5** (in.)  
Condition: ☐ Sound ☒ **Cracked** ☐ Root Intrusion ☒ **Loose Brick** ☒ **Deteriorated**  
Infiltration: ☒ None ☐ Joint ☐ Cracks ☐ Mortar ☐ Roots ☐ Wall

chimney cracked & deteriorated with loose brick

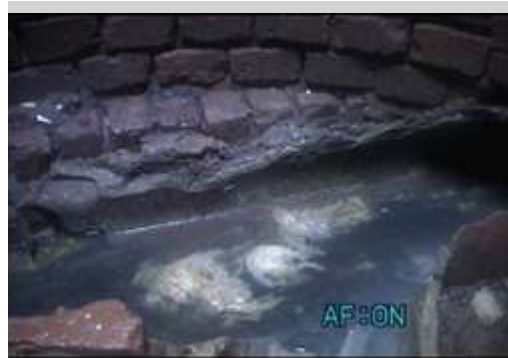
Defect 2

debris in the channel

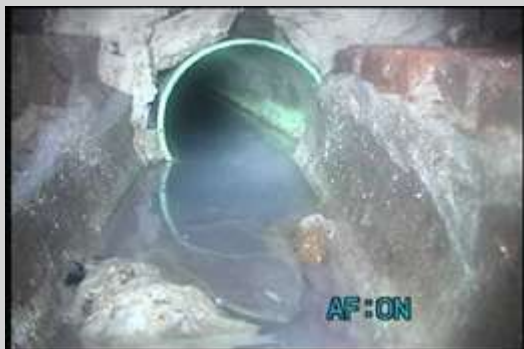
3 O'Clock Inflow

Pipe Height: **8.4** (in.) Rod and Bar (Angled)  
Pipe Material: **PVC** ☐ Pipe Lined  
Invert Depth: **6.16** (ft.) Flow Characteristics: **None**  
Deposits: ☒ None ☐ Mud ☐ Sludge ☐ Debris ☐ Grease  
Silt Depth: **0** (in.) Deposits Extent:  
Infiltration: **None** Pipe Seal Cond: **Cracked**
